Site Condition Report

Environmental Permit Variation

> West Newton A Wellsite

December 2018

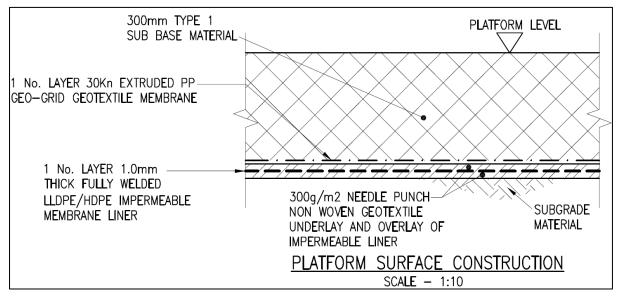
Figure 6.1: Wellsite Construction Cross Section

Once the surface of the site was level and the perimeter ditch excavated, an impermeable membrane, constructed from 1mm fully welded HDPE, was installed across the entire site area and perimeter ditch. The impermeable membrane is protected above and below from a layer of nonwoven needle punched geotextile, which protects the impermeable membrane from being damaged by subsequent operations. Inspections and testing of the impermeable membrane were performed during installation to confirm its integrity.

Geogrid was then laid across the site area and overlaid by 300mm thick layer of MOT Type 1 stone to provide a suitable working surface. Figure 6.1 details a cross section of the wellsite surface construction.

Three sides of the containment ditch were backfilled using 300mm twin walled perforated plastic pipe and backfilled using clean stone. The purpose of backfilling the perimeter ditches was to provide additional working area.

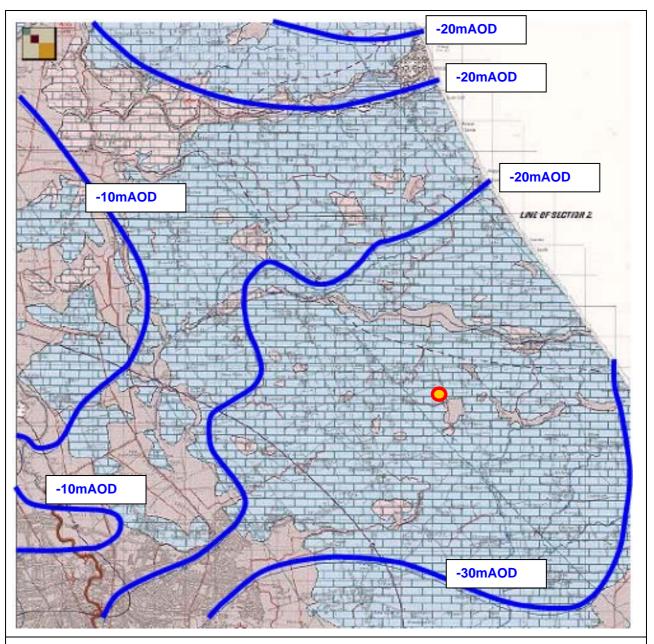
Figure 11: Regional Groundwater level contours from water level readings (1976) in the Chalk in East Yorkshire (NERC, 1980).

Inferred regional groundwater level contours in the confined Chalk for 1976 are presented as Figure 11 (NERC, 1980), which indicates elevations of between -20 and -30m below sea level in the area of the site. Regional groundwater flow is inferred to be south/southeasterly with shallow hydraulic gradients. However, as noted above the EA groundwater level data (if truly from the Chalk aquifer) would indicate an approximate 20m rise in groundwater levels within the confined Chalk beneath the site. No further information is available to URS to confirm this potential rise over the last 35 years. Although the information presented on Figure 11 is relatively old, the inferred regional groundwater flow directions are still considered valid even where groundwater elevations may have regionally changed.
